# 挡墙渗漏对富水砂层基坑变形性状的影响

# Effect of retaining wall leakage on the deformation behavior of foundation pit in water-rich sandy strata

摘要:针对深基坑漏水漏砂引发的灾害问题,探究基坑渗漏灾害发展规律及其控制方法对地下工程施工安全具有重要意 义。结合某富水砂层排桩深基坑渗漏灾害实例,阐释了基坑漏水漏砂灾害发展特征及诱发原因,并采用现场监测和数值模 拟方法对局部渗漏水下基坑变形性状及其控制措施进行了研究。研究结果表明:(1)基坑渗漏灾害发展是一个复杂的多场 耦合作用过程,具有一定的隐蔽性和突发性;(2)挡墙水平位移曲线分布发展过程为"斜线"形一"锅底"形一浅"倒 V"形一深 "倒 V"形,渗漏后挡墙最大水平位移为渗漏前的1.29~1.44倍;(3)墙后地表沉降曲线分布发展过程为"平勺底"形—"浅勺 底"形—"深勺底"形,沉降槽敏感区范围为1.00*h*e~1.20*h*e(*h*e为开挖深度),局部渗漏引起地表沉降槽加深变宽,渗漏后最大 地表沉降为渗漏前的1.16~1.65倍;(4)地下水位"跳跃式"波动变化特征可作为评判基坑渗漏灾害的前兆信号;(5)支撑轴 力变化随基坑开挖与支护过程动态调整从而协调变形发展,在基坑发生渗漏过程中支撑轴力出现小幅波动。采取"注 浆+高压旋喷桩"联合处治措施可有效应对富水砂层基坑渗漏灾害控制难题,研究成果可为基坑工程渗漏灾害理论研究与 控制提供参考。

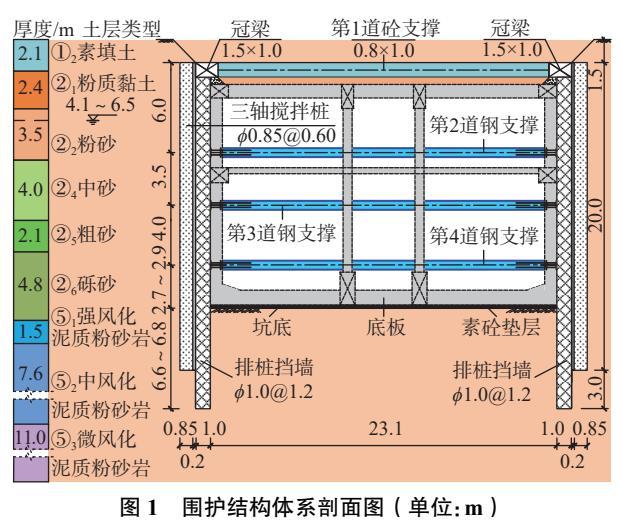
Fig. 1 Profile of retaining structure system (unit: m)

某城市地铁车站长条形深基坑工程,车站主体为 地下两层现浇钢筋砼箱型结构,基坑长470.0 m、宽 23.1 m、深18.0 m,上覆土层厚度2.34~3.26 m,车站采 用明挖顺作法施工。基坑试验段端头井开挖深度为 16.73~17.87 m,标准段开挖深度为15.50~16.41 m, 基坑支护系统采用钢筋砼钻孔灌注桩+三轴搅拌桩 止水帷幕+内支撑的型式(图1)。其中,钻孔灌注桩尺 寸为 ¢1 000 mm@1 200 mm,桩长23.0 m,桩墙外侧为 ¢850 mm@600 mm、深度20.0 m的三轴搅拌桩止水帷 幕,围护桩与搅拌桩间隙采用双液注浆加固,增强围 护结构止水功能。端头井基坑沿深度方向设置4道 横向水平支撑,第1道为梁式钢筋砼支撑(0.8 m×1.0 m, 间距9 m),第2、3、4道采用钢管支撑(直径609 mm,

壁厚16mm,间距3m)。

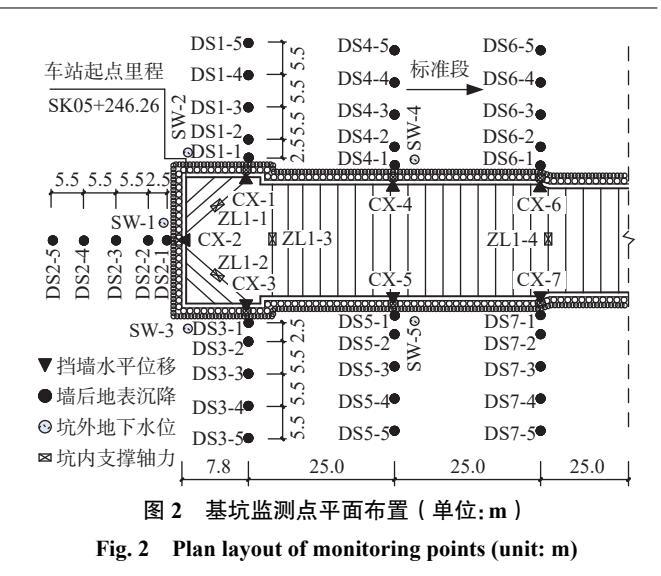
为全面掌握基坑开挖对挡墙变形和周围环境的 影响,分别对挡墙水平位移、墙后地表沉降、坑外地 下水位和坑内支撑轴力进行动态监测,测点平面布置 如图 2 所示。其中, 排桩挡墙水平位移布设 40 个测斜 点,分别记为CX-1--CX-40,累计位移报警值不超过 0.20%h<sub>e</sub>(h<sub>e</sub>为开挖深度),且不大于 20.0 mm, 变化速率 不超过 3.0 mm/d; 沿基坑周边间隔 25.0 m 布设 40 个墙 后地表沉降监测断面,每个断面设5个监测点,分别 记为 DS1-*i*—DS40-*i*(*i* 为测点编号), 累计沉降报警值 不超过 30.0 mm, 变化速率不超过 3.0 mm/d; 沿基坑 周边间隔 50.0 m 布设 24 个坑外地下水位监测点,分 别记为 SW-1-SW-24, 地下水位累计变化报警值不 超过±1.0 m, 变化速率不超过±0.5 mm/d; 在坑内间隔 50.0m分层布设14个内支撑水平轴力监测点,分别记 为 ZLm-1--ZLm-14(m 为支撑层数), 支撑轴力报警值 不超过 0.8 倍设计值。基坑开挖期间监测频率为 3 天 1次,特殊情况下监测频率可适当调整。

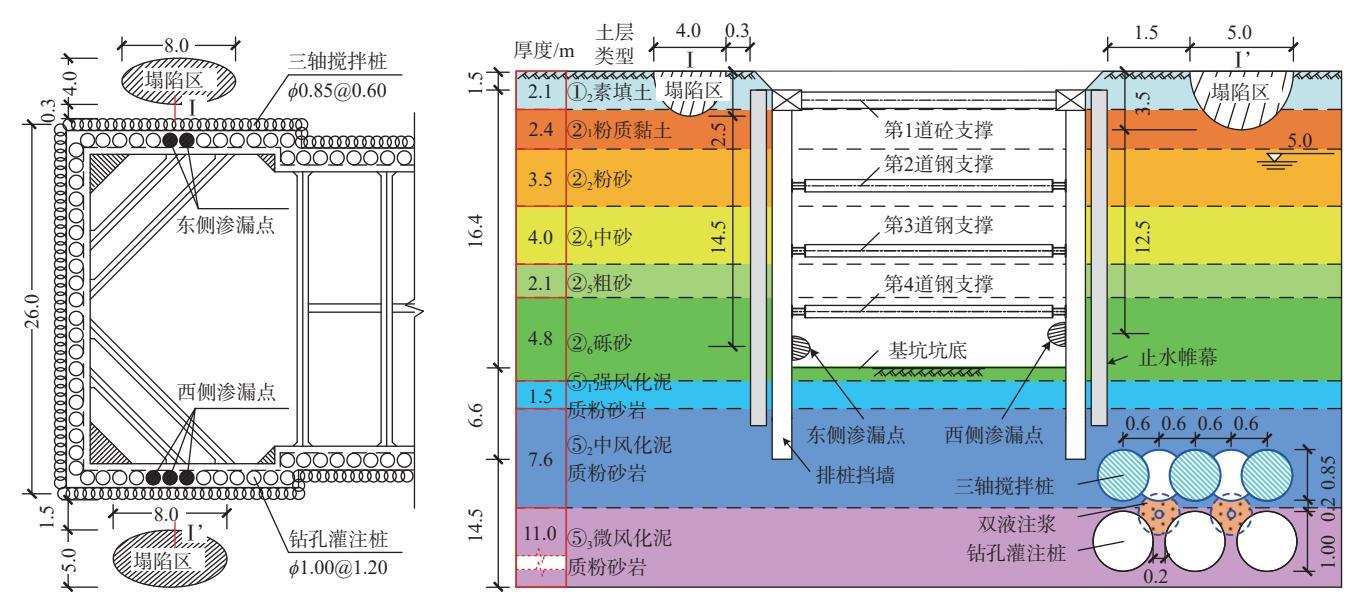
图 3 北端头井基坑局部漏水漏砂位置示意图(单位:m)

护桩桩间发生局部漏水、漏砂现象(图 3、图 4),呈现 渗漏速度快、流量大的特点,并在渗漏位置对应断面 地表发生瞬时塌陷,随后坑底漏水、漏砂速度减缓,地 表下陷也逐渐减慢直至停止。其中,第1次渗漏发生 在端头井西侧,渗漏点位置距地表深16.0 m,在距基坑 围护结构边沿1.5 m处发生地表塌陷,形成的塌陷区 域长、宽、深分别为8.0,5.0,3.5 m(图 3a),流砂量为 126.0 m<sup>3</sup>;第2次渗漏发生在端头井东侧,渗漏点位置 距地表深17.0 m,在距基坑围护结构边沿0.3 m处发 生地表塌陷,形成的塌陷区域长、宽、深分别为8.0, 4.0,2.5 m,流砂量为75.0 m<sup>3</sup>。对比前后2次渗漏情况 发现,渗漏位置均发生在北端头井长边方向、深度为 第4道支撑与坑底之间;渗漏以单点形式存在,不具

Fig. 3 Location of partial leakage of groundwater and sand during excavation (unit: m)

有连续性,且渗漏点位置同处一个断面;基坑漏水漏 砂持续时间为3~5min,具有突发性、瞬时性,且地表 沉陷伴随基坑漏水漏砂而发生。

根据现场调查与测试分析表明,本基坑发生漏水 漏砂灾害的主要原因为:①地质条件,基坑开挖深 度范围内主要为深厚富水砂层,砂性土层厚为10.0~ 15.0 m, 且较为松散, 见图 3(b); ②水力条件, 地下水 位埋深较浅,埋深为4.0~6.5m,水位变化受大气降雨 和临近江水影响显著,基坑坑内降水开挖与持续降雨 气候条件加剧坑内外地下水水头差,加之砂性地层条 件,极易引起基坑发生渗透破坏;③止水帷幕质量缺 陷,排桩围护结构与止水帷幕之间、钻孔灌注桩之间 存在 0.2 m 的间隙(图 4b),该间隙虽采用双液注浆增 强止水作用,但仍有可能成为基坑渗漏的水力通道: 止水帷幕桩现场钻芯取样发现,岩芯局部较破碎,且 可见未完全固结泥砂,在砂层与泥质粉砂岩层界面上 下一定深度范围桩体存在微张裂隙或裂隙间局部夹 裹少量泥砂的现象,此区域为高水土压力作用下止水 帷幕发生破坏、产生局部渗漏的薄弱点;④止水帷幕 局部大变形伤损,基坑开挖引起刚度相对较小的水泥 土帷幕结构大变形,局部因张裂而出现渗漏水,在高 水土压力环境下水力损伤效应加剧,进而导致隔水作 用失效。

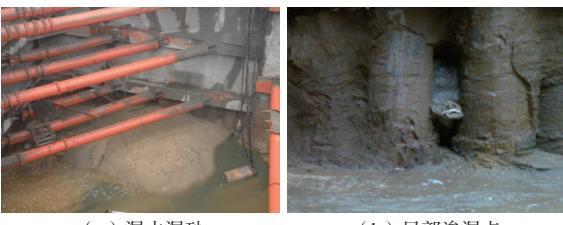
(a)漏水漏砂
 (b)局部渗漏点
 图 4 北端头井基坑漏水漏砂灾害现场观测
 Fig. 4 Field observation of leakage of water and sand during excavation

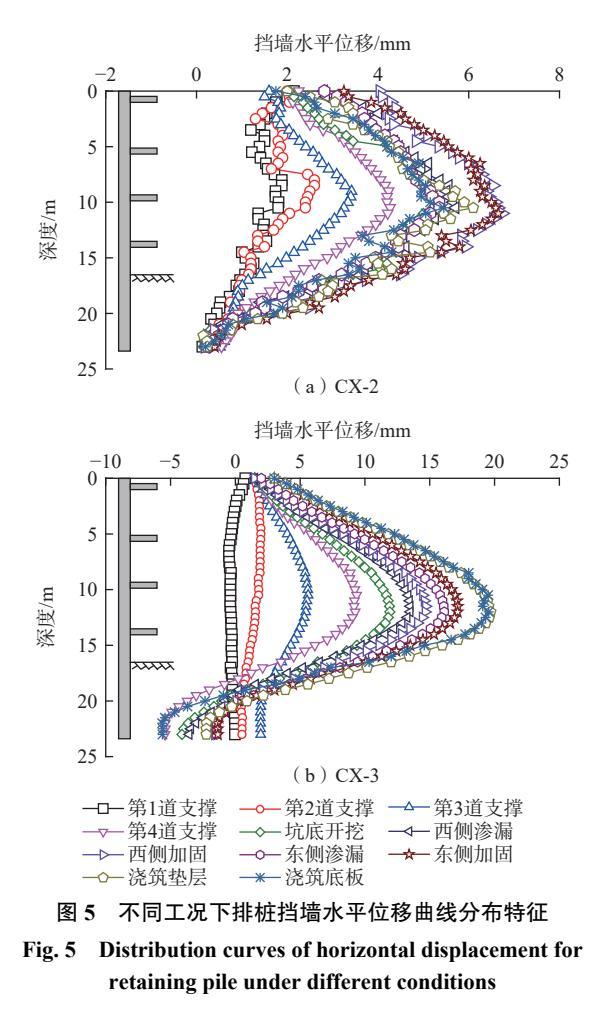
图 5 为不同工况下排桩挡墙水平位移曲线分布特 征。由图可得,随着基坑开挖深度增加,挡墙水平位 移显著增大,其分布曲线呈"鼓肚"形;当基坑开挖至坑 底时,测点CX-2(北端头井短边方向)、CX-3(北端头 井长边方向)挡墙最大水平位移分别为 5.25, 11.92 mm; 当基坑发生局部渗漏后,测点 CX-2、CX-3 挡墙最大 水平位移分别为 6.75, 17.16 mm, 相较于渗漏前分别增 加了 28.57%、43.96%; 当基坑底板浇筑完成后, 测点 CX-2、CX-3 挡墙最大水平位移分别为 5.45, 19.55 mm, 相较于渗漏前分别增加了 3.81%、64.01%; 测点 CX-2 与测点 CX-3 对比可知, 基坑局部渗漏会加剧挡墙水 平位移,且受基坑尺寸和坑角效应的影响[29-30],局部 渗漏下基坑长边方向挡墙水平变形大于短边方向。 主要原因可能有:①基坑发生渗漏引起桩后水土流 失,导致挡墙遭受附加动水荷载的冲击作用;②基坑 渗漏延误工期,使得未形成封闭的围护结构暴露时间 增长,挡墙变形的时间效应突显;③桩后注浆加固和 地表大体量素混凝土回填,以及注浆加固后地下水位

因降雨迅速回升,导致桩后水土压力增大。

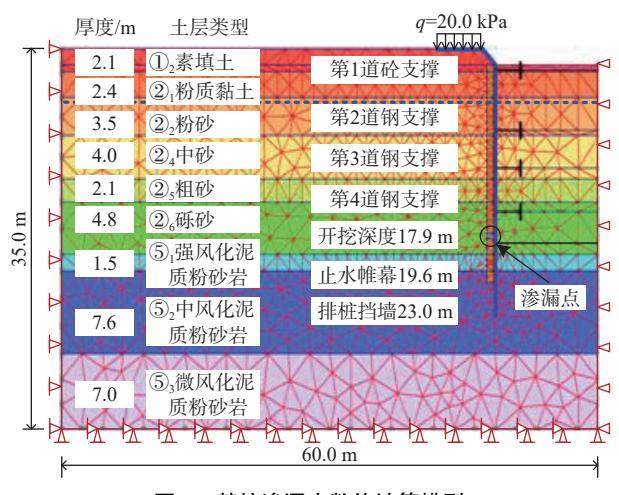
图 6 基坑渗漏水数值计算模型 Fig. 6 Numerical model of leaking groundwater of the pit

上述分析表明,基坑局部渗漏对围护结构和周围 地层变形具有重要影响。为此,借助 PLAXIS<sup>2D</sup>建立 考虑渗流作用的砂土-止水帷幕-排桩挡墙有限元计算 模型,模拟基坑降水开挖和围护结构局部渗漏条件, 对局部渗漏条件下排桩挡墙变形和墙后地表沉降 进行计算分析。结合端头井段深基坑实际,取基坑开 挖尺寸为深度17.9m、宽度23.0m,开挖深度范围主 要为黏性土层和砂性土层。考虑模型的对称性后取 1/2 模型进行计算, 建立的数值计算模型尺寸为高度 35.0 m、宽度 60.0 m(图 6), 模型共计 1 789 个单元, 14 503 个节点。在数值模拟计算中, 岩土层采用实体 单元模拟,假定地基土层厚度沿水平方向均匀分布, 土体为均质、各向同性材料,材料服从土体硬化模型 (HS模型)<sup>[31-33]</sup>,各土层计算参数取值详见表1和表2。 排桩挡墙和内支撑采用结构单元模拟,止水帷幕采用 实体单元模拟,材料均服从线弹性本构模型,其计算 参数取值为:止水帷幕重度为 20.0 kN/m<sup>3</sup>, 黏聚力为 120.0 kPa, 内摩擦角为 40.0°, 弹性模量为 0.4 GPa, 泊松 比为 0.25; 挡墙重度为 25.0 kN/m<sup>3</sup>, 弹性模量取 31.5 GPa, 泊松比为 0.2; 混凝土支撑重度为 25.0 kN/m<sup>3</sup>, 弹性模量 取 30.0 GPa, 泊松比为 0.2; 型钢支撑重度为 78.0 kN/m<sup>3</sup>, 弹性模量取 210.0 GPa, 泊松比为 0.3。本模型中通过 在挡墙结构上预设渗漏通道来实现局部渗漏水的模 拟, 渗漏点距坑底 0.9 m, 尺寸为 0.2 m×0.2 m, 渗漏区 域实体单元渗透系数为 8.00×10<sup>-2</sup> cm/s。

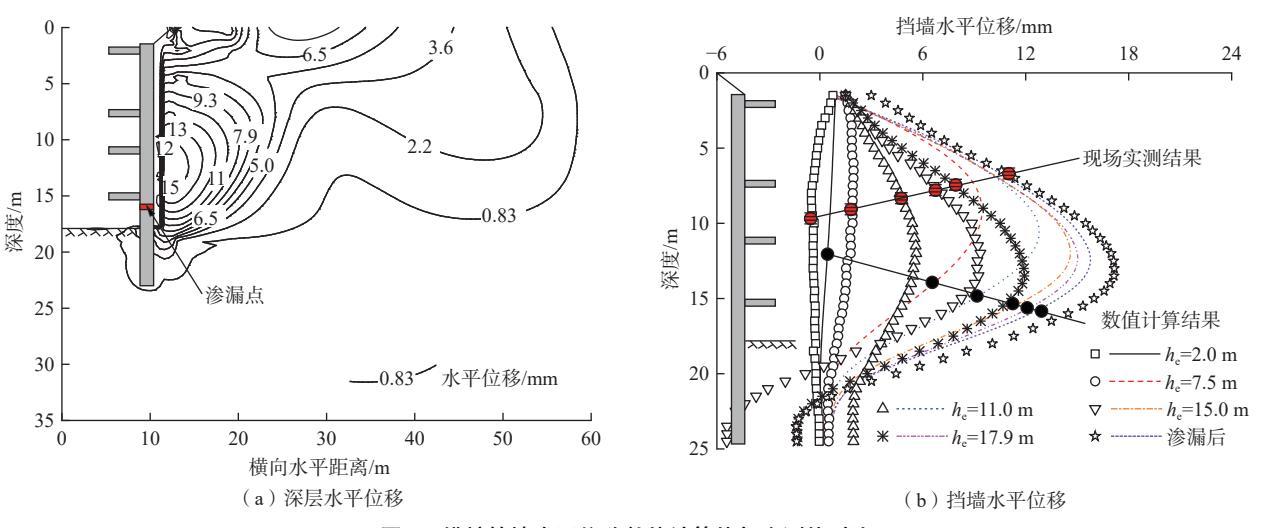
图 7 排桩挡墙水平位移数值计算值与实测值对比

图 7 为排桩挡墙水平位移数值计算值与实测值对 比。由图可知,挡墙水平位移曲线数值计算结果与实 测结果发展趋势基本一致,挡墙水平位移曲线随基坑 开挖深度呈渐进发展过程,其发展过程可描述为"斜 线"形一"锅底"形一浅"倒 V"形一深"倒 V"形;各工况 下挡墙最大水平位移计算值分别为 0.91, 9.45, 12.78, 14.60, 15.03, 15.77 mm,实测值分别为 0.77, 1.97, 5.62, 9.36, 11.92, 17.16 mm,渗漏后挡墙水平位移计算值较 渗漏前增加了 4.92%;局部渗漏下挡墙最大水平位移 计算值与实测值分别为 0.09%*h*<sub>e</sub>、 0.10%*h*<sub>e</sub>,挡墙最大水 平位移位置(*H*<sub>max</sub>)计算值与实测值分别为 0.77*h*<sub>e</sub>、 0.73*h*<sub>e</sub>; 计算值与实测值相比,渗漏后挡墙变形均呈增加趋势, 但渗漏后挡墙水平位移计算值偏小,原因是数值计算 中未能体现渗漏条件下动水荷载对挡墙的冲击作用。 3.2 渗漏水对墙后地表沉降的影响

(2)挡墙水平位移随开挖深度发展过程为"斜线" 形一"锅底"形一浅"倒 V"形一深"倒 V"形分布;局部 渗漏下挡墙最大水平位移为 0.10%he,挡墙最大水平位 移位置为 0.73he;渗漏后挡墙最大水平位移为渗漏前 的 1.29~1.44倍,且端头井长边方向挡墙水平变形大 于短边方向。

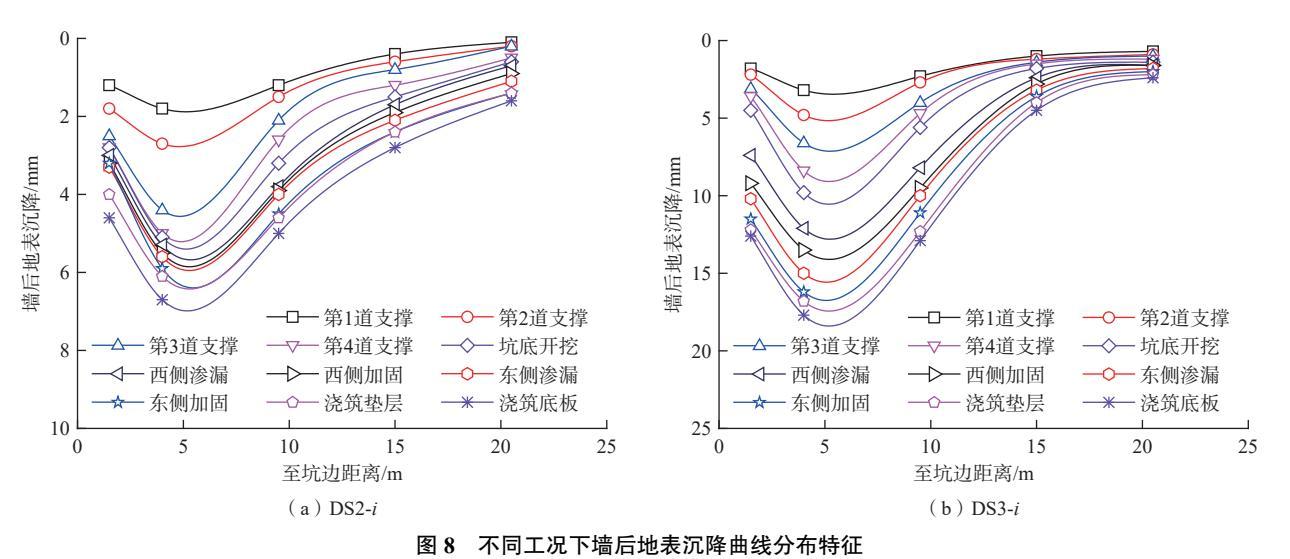
Fig. 8 Distribution curves of ground surface settlement under different conditions

图 8 为不同工况下墙后地表沉降曲线分布特征。 由图可得,随着基坑开挖深度的增加,地表沉降不断 增大呈下凹趋势,开挖深度越大"勺形"凹槽分布越显 著,即基坑开挖深度越大,"勺底"越深(沉降量越大), "勺把"越长(影响范围越大);当基坑开挖至坑底时, 断面 DS2-*i*(北端头井短边方向)、DS3-*i*(北端头井长 边方向)的最大地表沉降量分别为 5.10, 9.80 mm; 当基

坑发生局部渗漏后,断面 DS2-*i*、DS3-*i*的最大地表沉降量分别为 5.90, 16.20 mm,相较于渗漏前分别增加了

15.69%、65.31%; 当基坑底板浇筑完成后, 断面 DS2-i、 DS3-i 的最大地表沉降量分别为 6.70, 17.70 mm, 相较 于渗漏前分别增加了 31.37%、46.28%。基坑渗漏前后 对比表明, 局部渗漏引起地表沉降槽进一步加深变 宽, 最大地表沉降量可达渗漏前的 1.65 倍, 且端头井 长边方向最大地表沉降量明显大于短边方向。

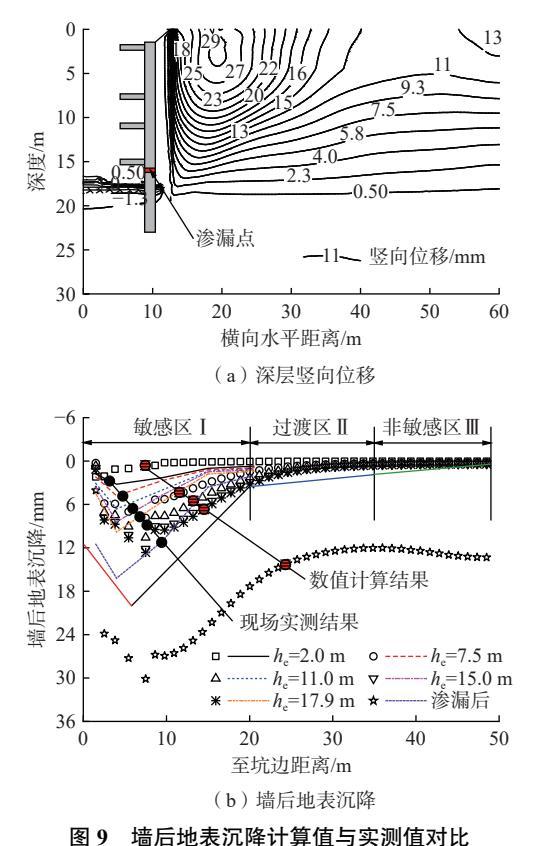
图 9 为墙后地表沉降数值计算值与实测值对比。 由图可知,墙后地表沉降曲线随基坑开挖由"平勺底" 形—"浅勺底"形—"深勺底"形发展;根据墙后地表沉 降槽分布特征,地表沉降影响范围可划分为敏感区 (I区)、过渡区(II区)和非敏感区(III区),敏感区内 地表沉降量最大,其范围为1.00*h*。~ 1.20*h*;各工况下 墙后最大地表沉降计算值分别为2.19,7.86,10.58,12.15, 12.63,30.12 mm,实测值分别为3.20,4.80,6.60,8.40, 9.80, 16.20 mm, 渗漏后地表沉降计算值为渗漏前的 2.38 倍。由此说明, 基坑渗漏会引起墙后地表沉降大 幅增加, 且对敏感区影响最为显著。

Fig. 9 Comparison of measured and calculated value of ground

surface settlement

(3)墙后地表沉降曲线呈"勺形"凹槽分布,其发展 过程为"平勺底"形一"浅勺底"形一"深勺底"形;地表 沉降影响范围可划分为敏感区、过渡区和非敏感区, 敏感区范围为1.00*h*。~1.20*h*。;基坑渗漏引起地表沉 降槽加深变宽,渗漏后最大地表沉降为渗漏前的1.16~ 1.65倍。

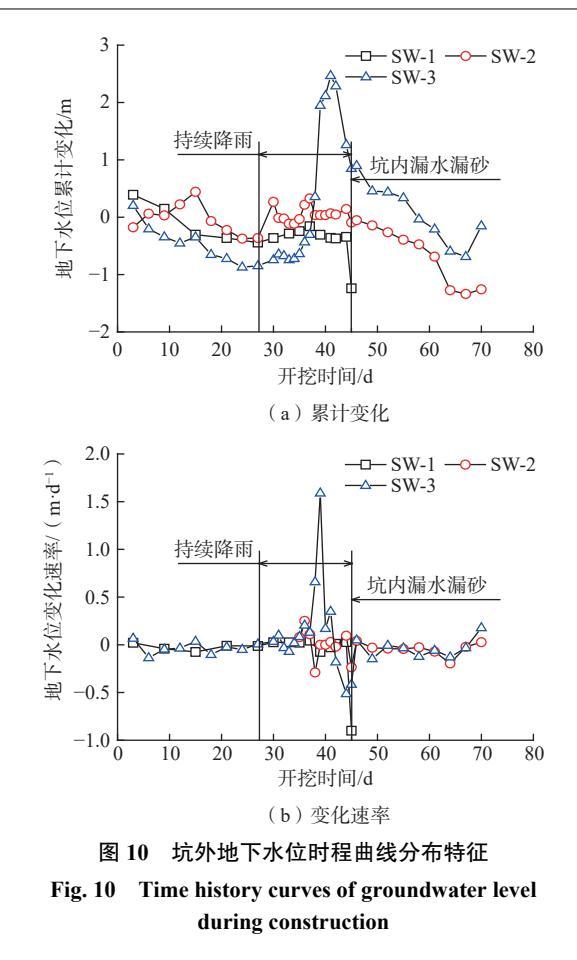
图 10 为基坑施工期间坑外地下水位及其变化速 率时程曲线分布特征。由图可得,在基坑北端头井施 工期间,坑外地下水位随基坑开挖过程呈缓慢下降趋 势,而后逐步趋于稳定,受持续降雨影响北端头井地 下水位出现快速回升;基坑发生渗漏过程中,坑外地 下水位急剧下降,地下水位变化速率呈现"跳跃式"变 化,其中测点 SW-3 地下水位累计变化量及变化速率 均超过监测报警值;基坑渗漏险情处治后,坑外地下 水位变化逐步恢复稳定状态。基坑渗漏水发生、发展 过程表明,科学地控制地下水位,全面掌握地下水位

动态变化,确保围护结构防渗效果是预防基坑发生渗 漏灾害的有效措施。

(4)基坑发生渗漏前后地下水位波动显著,其"跳 跃式"变化特征可作为基坑发生渗漏灾害的前兆信 号;坑内支撑轴力变化随开挖深度和支撑施加不断发 生调整从而协调变形发展,其演变过程随时间呈波动 式渐进增长,在基坑发生渗漏过程中支撑轴力出现小

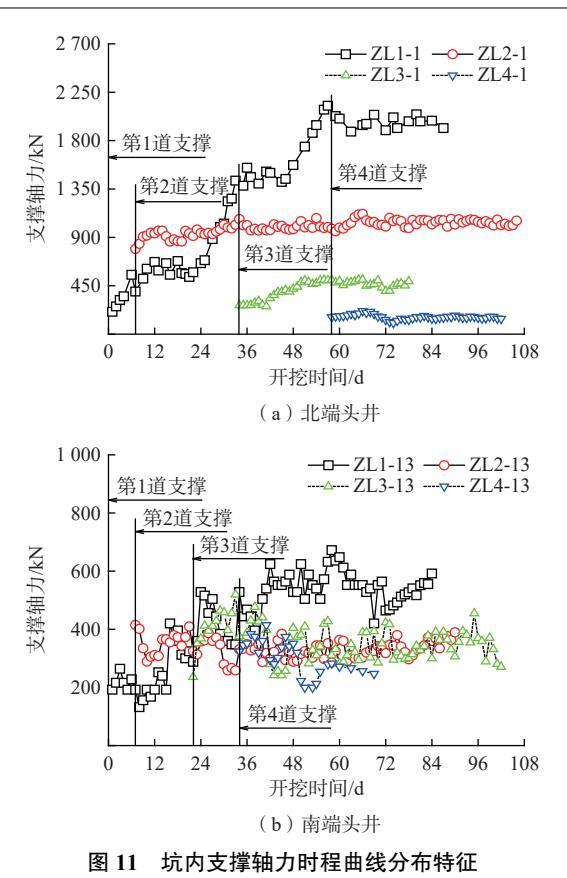
Fig. 11 Time history curves of axial force of internal support

图 11 为基坑内支撑轴力时程曲线分布特征。由 图可得,随着基坑开挖深度增加,坑侧主动土压力逐 渐增大,在侧向荷载与内支撑作用下,支撑轴力随时 间呈渐进波动式增长而后逐步趋于稳定,第1道支撑 轴力稳定的时间为 30~60 d, 第 2、3、4 道支撑轴力稳 定的时间为15~20d;端头井第1、2、3、4道支撑轴力 值变化范围依次为 208~2 124、508~1 118、236~660、 104~415 kN,各道支撑轴力最大值分别为设计值的 0.87, 0.75, 0.45, 0.41 倍。由此说明, 第1道混凝土支 撑主要承担挡墙后土压力荷载,其轴力值较大,而第 2、3、4 道钢支撑轴力相对较小,钢支撑设计相对偏保 守。在基坑发生渗漏过程中,支撑轴力出现小幅波 动,北端头井(ZL1-1)和南端头井(ZL1-13)第1道支撑 轴力最大值分别为 2 124, 672 kN, 南端头井支撑轴力 为北端头井的 31.6%,即南端头井第1道支撑轴力明 显小于北端头井,主要原因是北端头井出现渗漏灾害 后.在南端头井施工过程中对原围护结构采取了强化 处治措施。
